Damaging Profile of SS-304 Crevice Corrosion in Chloride Environments

Abstract: Type 304 stainless steel (SS-304) has wide industrial applications due to its weldability and resistance to corrosion. However, it suffers crevice corrosion especially in chloride environments. The damaging profiles of its crevice corrosion in chloride environments were evaluated. The crevice assembly used for this study comprised of coupon (SS-304), polytetrafluoroethylene (crevice former) and fasteners (titanium bolt, nut and washers) designed in three configurations with crevice scaling factor of 8, 16 and 24, respectively. The configurations had 40 crevice sites and immersed in various chloride solution concentrations of 1.5, 3.0 and 4.5 w/w % simulating environmental conditions A, B, and C respectively for 45 days in full immersion test. ASTM G-78 was used to estimate the value of % area attacked over time. The obtained results showed that the highest percentage of creviced area was attacked in marine environment followed by brackish and freshwater in that order. The damaging profile confirms the severity of chloride environment and the possible control by reducing the possible percentage of chlor

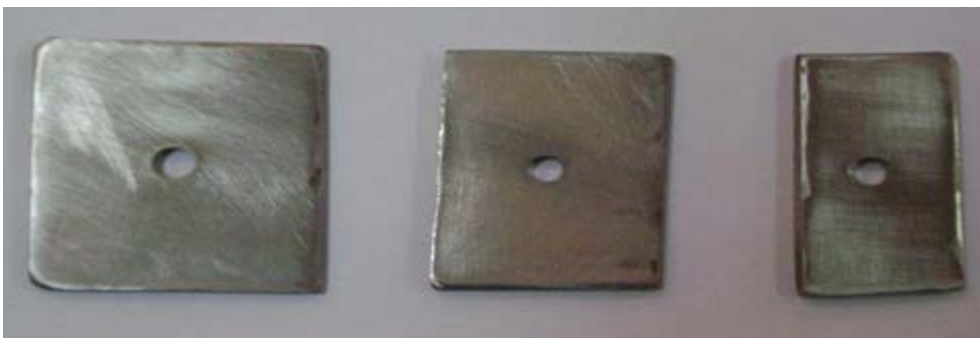
Figure 1: Cut and Polished corrosion test coupons of varied dimension

Samples of stainless (304) were obtained for testing. The coupons (Figure 1) used for crevice corrosion and fraction of sites damaged testing were 50 mm X 50 mm X 3 mm (Type A), 50 X 40 mm X 3 mm (Type B), or 50 mm X 30 mm X 3mm (Type C) plates dimensioned with a 600 grit finish. Teflon crevices (Figure 2) were prepared as the crevice former on the coupon for crevice corrosion tests. All samples were degreased with acetone in an ultrasonic cleaner prior to assembly and testing. The aqueous simulant used for this study were prepared at 1.5, 3.0 and 4.5 NaCl w/w, to simulate fresh, brackish and marine water environments respectively. The creviced assembly (Figure 3) remained immersed in solution between and during testing.

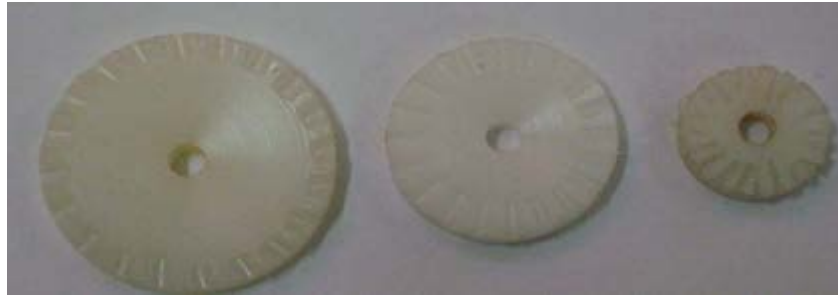
Figure 2: Fabricated Crevice former

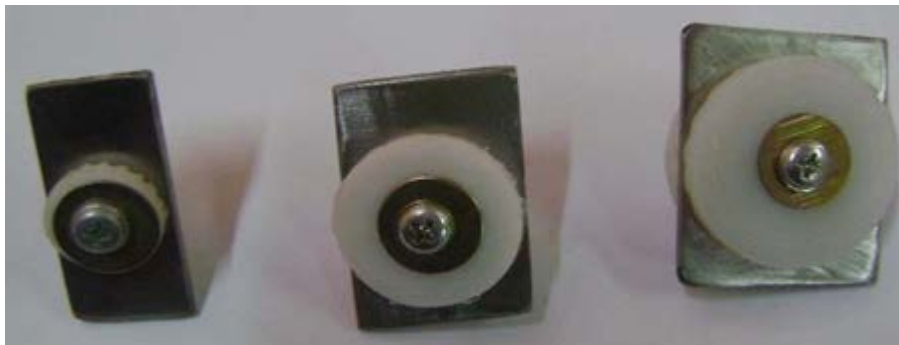
Figure 3: Multiple Crevice Assembly for Crevice Corrosion Test according to ASTM G78. Coupon Analyses

The crevice test assembly (Figure 3) consisted of a bolt on which the following pieces were placed. First, a Teflon crevice washer dimension according to Table 1, a coupon, a shoulder washer and the nut to secure the pieces together. This assembly was then placed into a plastic specimen cup with 100 ml of the simulant solution and capped. The containers were swirled regularly during the work week in order to keep the solution mixed. Assemblies were taken apart once in 15 days and the areas under the spokes of the crevice washers were examined for depth of attack (crevice corrosion propagation). Samples were reassembled and placed back into the simulant solution. Surface visual analyses were achieved by using reflected optical microscope and digital camera.

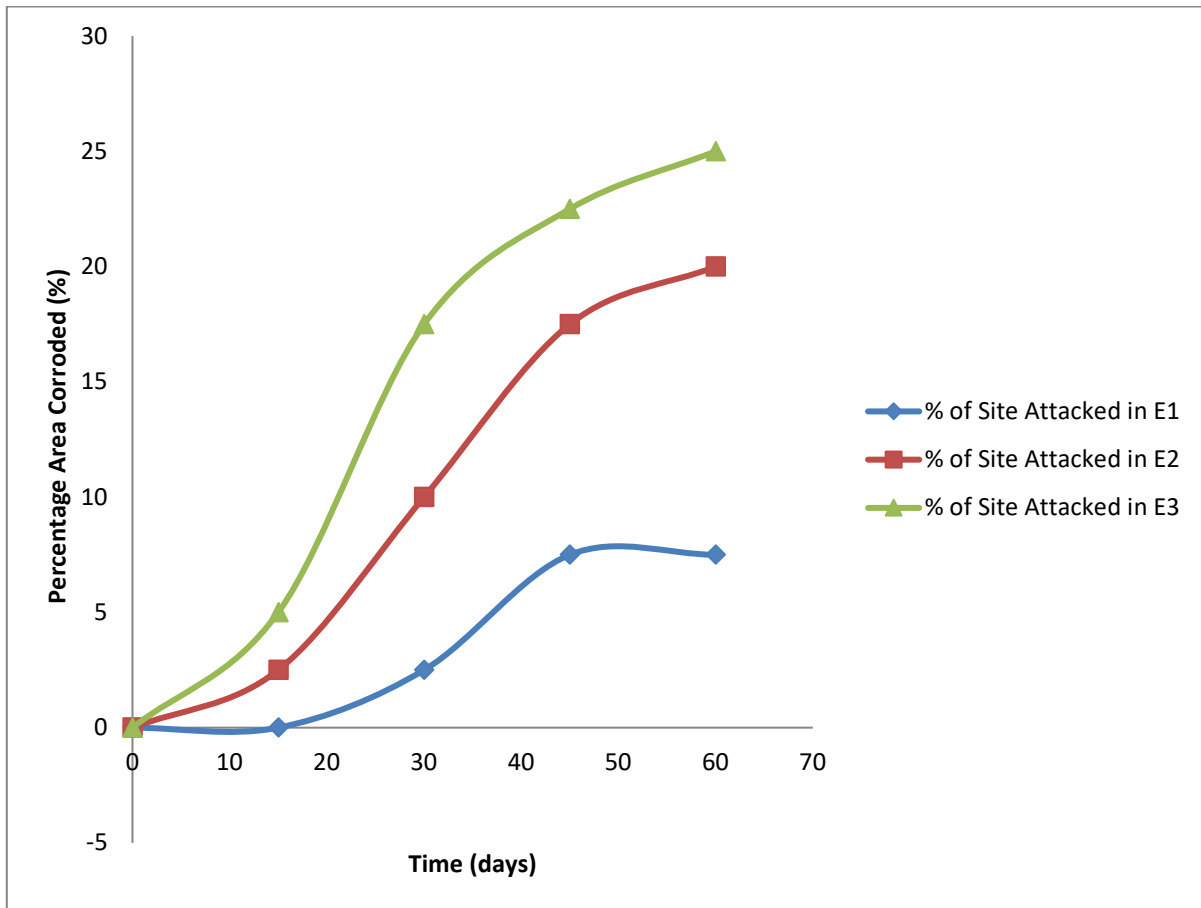
The results from image analysis from this group show unequivocally that the crevice scaling parameter observed in this coupon type gives the best crevice corrosion protection. In this crevice configuration, the highest coverage of attack observed was 25% in 60 days of immersion in marine environment, 20% in brackish condition and 7.5% in freshwater condition. This further confirms that the higher the crevice scaling factor, the better the creviced corrosion are put under control.

Figure 6: Effect of Varied Salinity on Frequency of Attack in Coupon Type C

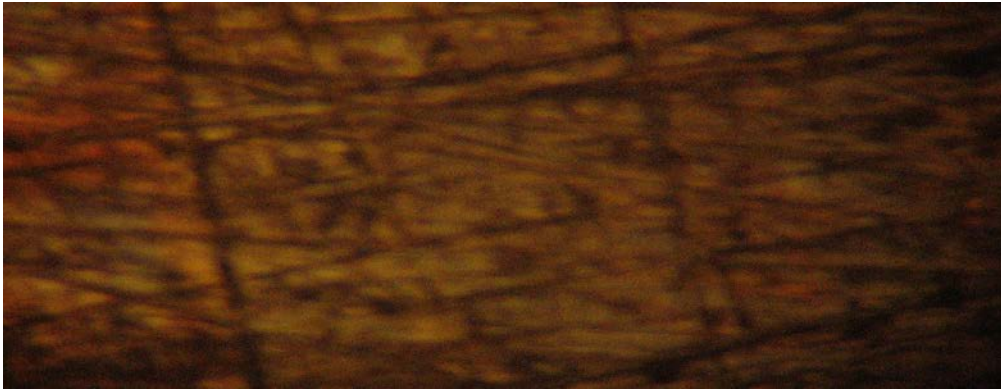
Figure 7 shows the surface morphological picture of the as-received SS-304 samples respectively at X200 magnifications. The SS-304 sample appears to be a homogeneous, fine grained microstructure with randomly spaced inclusions. Also, the surface morphological conditions of corroded surfaces in simulated freshwater, brackish and marine environments were also presented at different time interval to evaluate the effect of time on the rate of propagation of crevice corrosion in different simulated environments. These are presented in Tables 1, 2 and 3. Comparing the morphological details in each of the environments with the as received (Figure 7) component shows different levels of damage across the environments, mostly severe in marine environments. Some evidence of localized attack such as micro-pits was detected at the metal-resin boundary in each simulated chloride containing environment. These pits are believed to occur as a result of certain inclusions in the metal matrix [8]. During immersion tests under static conditions, the SS-304 in fresh water condition did not show much appreciable damage even after immersion for a period of 45 days, but the rate of damage are much more severe in brackish condition and mostly severe in marine conditions.

Figure 7: Optical micrographs of the as-received 304 austenitic stainless steel sample

While comparing these conditions with as received conditions shown in Figure 7, it is further confirmed that there are possibility of repassivation of the SS-304 surface in use at freshwater conditions of test, while the rate of crevice corrosion propagation is faster in brackish conditions and fastest in marine condition. This was in appreciable agreement with the other research works [9, 10].

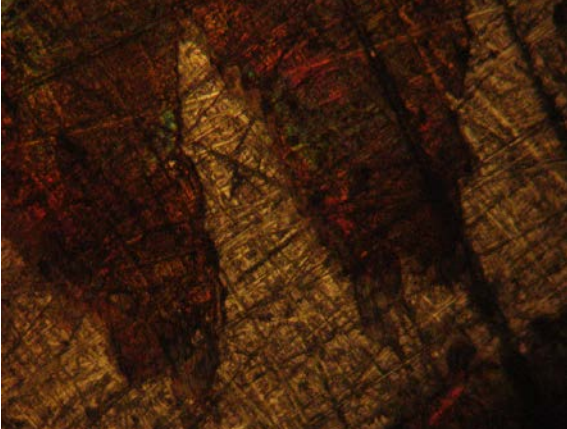
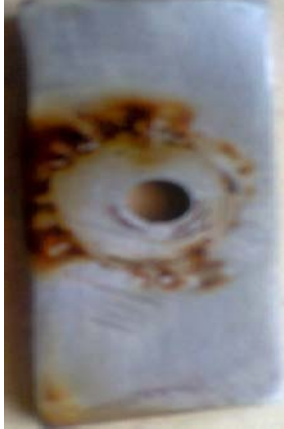
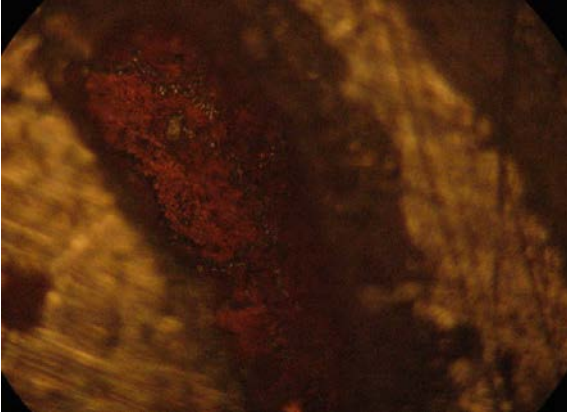
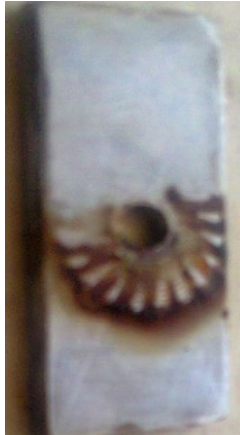
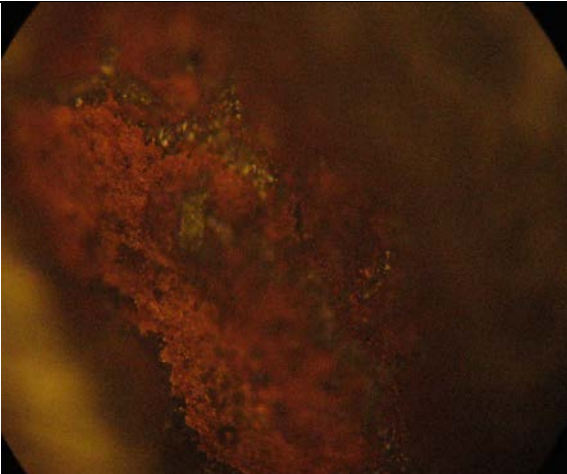
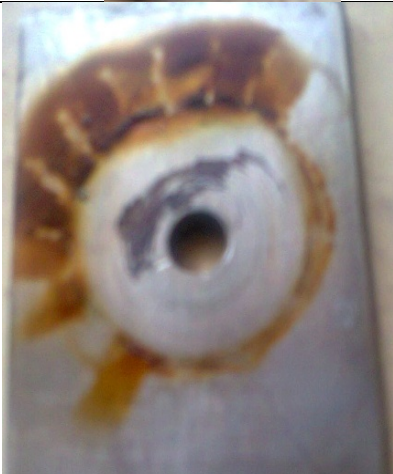
Table 4: micrographs of corroded surfaces in simulated Marine water

In comparing morphological details in each of the simulated environments, it is observable that damages in marine are more pronounced as evident in Table 4.3, even at 15 days of immersion. The morphological damages in freshwater is minimal when compared to the brackish condition. This is basically because of the concentration of chloride

solutions available in the crevices over the period of time. Therefore, the changes in the surface conditions occur much more rapidly in marine condition than in the case of freshwater and brackish conditions. For this reason, the general compromise is that crevice corrosion of SS-304 is more detrimental in marine environment [9,10].

The distributions of pits observed at positions observed in each chloride containing environments are different from each other. The pits presented in the figures put in Tables 2 and 3 are shallower than those in Table 4. These shallow pits correspond with the low corrosion rate observed in environment with lower concentration of chloride, this explains the fact that crevice corrosion nucleates by the formation of pits in the crevice region at the initiation of crevice corrosion. Similar observations have been previously reported [11].
